FLOATING BREAKWATER PROTOTYPE TEST PROGRAM: SEATTLE
WASHINGTON(U) COASTAL ENGINEERING RESEARCH CENTER
VICKSBURG MS E E NELSON ET AL. MAR 86 CERC-MP-86-3

FLOATING BREAKWATER PROTOTYPE TEST PROGRAM: SEATTLE, WASHINGTON

March 1986

Final Report

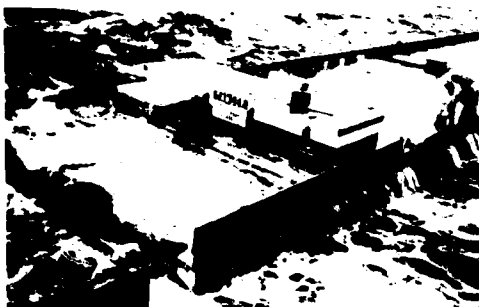
3.01 Freeboard and Overtopping. The initial freeboard of the floats varied from 15 to 18 in. No additional ballast was required to trim the breakwater. After the anchor lines had been secured, the additional vertical anchor line load lowered the freeboard to 13 in., 5 in. lower than originally desired. The increased draft (and reduced freeboard) may have improved the wave attenuation capabilities slightly, but the reduced freeboard undoubtedly caused an increase in the amount of wave overtopping. Incident waves estimated to

be 2 ft high caused 6-in.-deep water to flow across the deck (photo A-19). This made moving about on the rolling, slippery deck an extremely precarious proposition (photo A-20). On more than one occasion, tools and equipment were swept overboard, and life vests were a standard dress item. In addition, care had to be exercised in mooring the work boat to avoid swamping it with the water which ran off the leeward side of the breakwater (photo A-21).

Photo A-19. Waves overtopping the low deck (13-in.) freeboard allowing considerable wave overtopping.

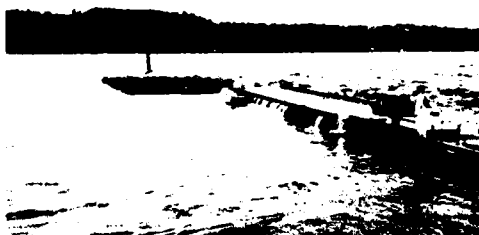
Photo A-21. Overtopping waves swamping a work skiff.

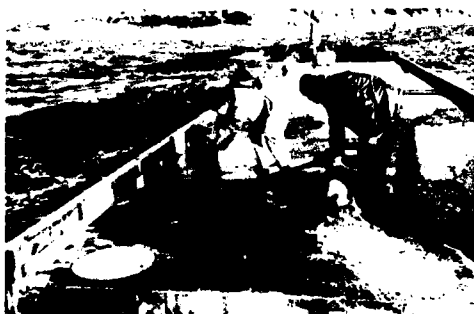
3.03 Leakage. Aside from damage done to the various connectors (discussed in Appendix D), the concrete structure survived the test period undamaged; however, water leaking into the end compartment provided a few anxious moments. The leaks occurred at the entrance hatches and at the through-hull Dywidag bolt holes. The hatches were designed to be flush with the deck to facilitate the future use of the floats in the Friday Harbor Marina project. Unfortunately the hatches were the low point of the deck, and faulty seals turned the hatches into drains for overtopping waves. Quick calculations indicated that the floats might be negatively buoyant if the end compartments were filled with water, and on two occasions emergency pumping operations were carried out to avoid field verification of the buoyancy calculations (photos A22 and A-23). Leaks also developed where the neoprene gaskets sealed the twenty 1-3/4-in.-diam bolt holes cast into the end of

Photo A-22. About 3,000 gallons being pumped from an end compartment after a storm.

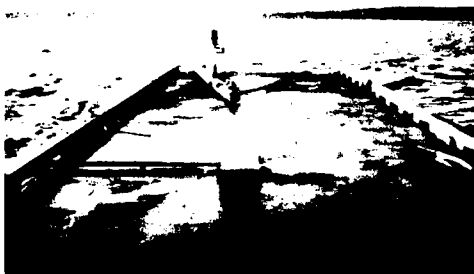
3.04 Debris Effects. On several occasions, storms, accompanied by extreme high tides, produced large amounts of floating debris. Logs as large as small automobiles were found on the breakwater deck one day and were gone the next. While the logs took their toll of monitoring instrumentation, no damage to the floats themselves was attributed to debris (photo A-24).

Photo A-24. Photo showing type of debris which washed across the deck.

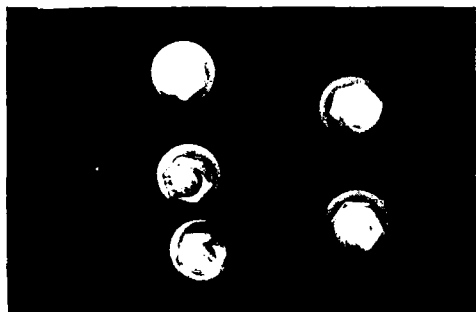
Ten conveyor belt connections were inspected. Eight of the connections, which use five 1/2- by 2-in. nylon bolts, had one or more broken bolts. Only those connections on the perimeter of the breakwater were accessible for inspection. Two bolt patterns were used in fastening the belting together, but no conclusions regarding their relative performance could be drawn (photos B-14 and B-15).

Photo B-14. Melting the ends of the 1/2-in.-diam nylon bolts (note 2-1-2 bolt pattern).

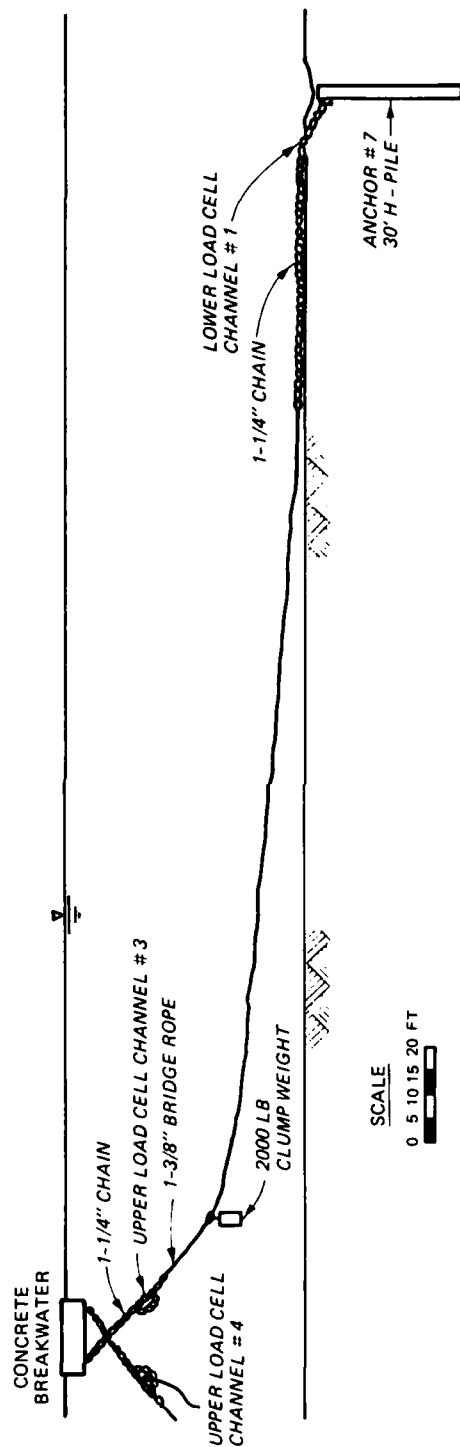
FIGURE C-1. Measured Catenary for Anchor Line No. 7

Anchor line lengths were sized to provide a slope no steeper than 1 vertical to 4.5 horizontal. Actual catenary measurements of the concrete breakwater's anchor line No. 7 were made by divers during the test program. Results of these measurements are shown in figure C-1. Positioning of the four corner

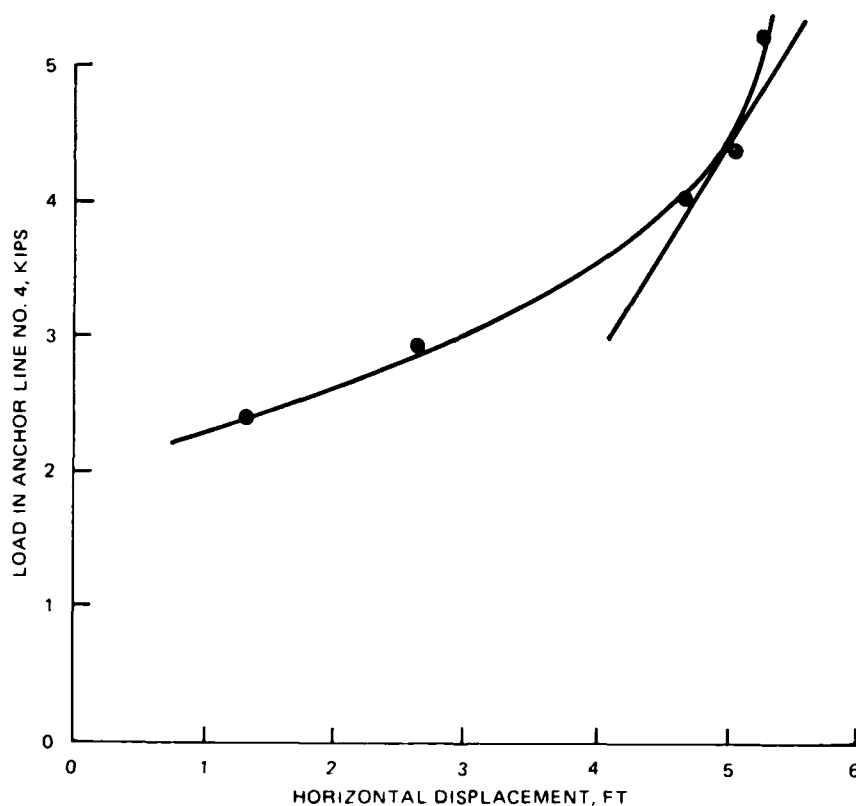
FIGURE C-6. Concrete Breakwater Anchor Line Pull Test:
Anchor Line Load versus Horizontal Displacement

2.04 Anchor Line Stiffness Test (Pull Test). On 18 August 1983, a marine tugboat was used to pull on the concrete breakwater with varying loads while surveying instruments measured horizontal displacements of the breakwater, and load cells monitored anchor line forces and tow line loads (photos C-16 and C-17). This test was conducted to obtain simultaneous measurements of breakwater lateral displacement and the resisting anchor force. Results of the test are shown on the plot of anchor line force versus horizontal displacement (figure C-6). The anchor stiffness (slope of this line at any point) varied

from 300 lb/ft, when the load in the anchor line was 2,000 lb above ambient, to 1,700 lb/ft at a load of 5,000 lb above ambient. The rapidly increasing anchor stiffness measured in this test explains why visual observations of the concrete breakwater did not detect a measurable lateral displacement even in fast currents or high waves (photo C-18).

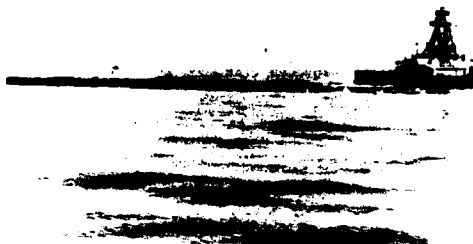
discovered the problem 3 months later, several tenths-of-an-inch of the steel anchor chain had been worn away (photo C-14). Anchor line No. 6 was replaced with the aid of commercial hard-hat divers and US Army Corps of Engineers (Corps) equipment and personnel (photo C-15).

Photo C-15. A new anchor chain being readied for installation.

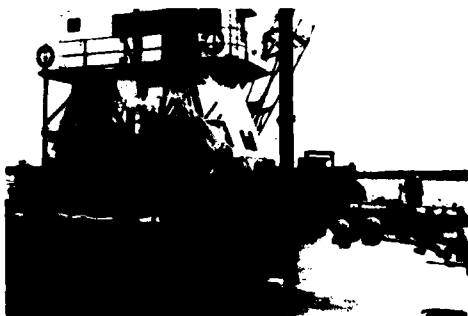
Photo C-24. Photo of marine growth covering the nylon anchor line.

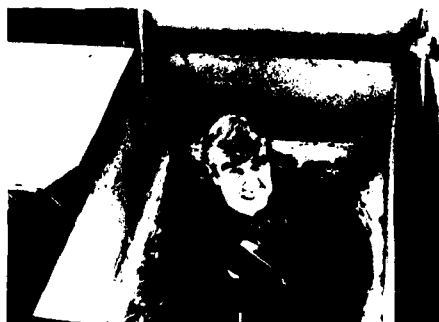
The equipment installation process was complicated by the early onset of what was to be an abnormally severe winter storm season. Water leaked into the interior storage compartment from waves which continually washed over the deck creating an unusually cold and damp working environment (photo F-17). Shortly after being anchored in place, three of the spar buoys were found broken. All the buoys were broken where the 8-ft-long staff joined to the main body of the buoy. A third buoy was missing completely. The probable cause of the damage was fast tidal currents and/or waves. The opening of the gillnet fishing season caused additional problems. Although the test site location had been well publicized to all mariners, particularly local fishermen, 600 ft of gill net became entangled in the breakwater and broke one of the two remaining wave staffs. Two new buoys were deployed; but, within a week, one buoy had broken and another had been torn out by a large wave-borne log (photo F-18). By the end of the first week in October 1982, seven spar buoys had been damaged or destroyed (photo F-19). By mid-October,

Photo F-14. Photo showing secondary hatch to keep waves from washing into the equipment compartment.

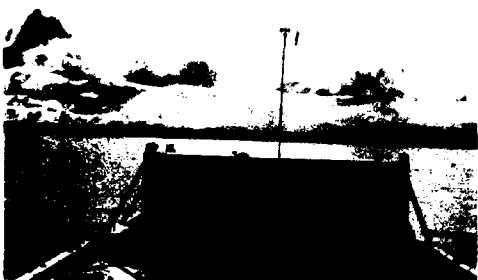
Photo F-21. Photo depicting deck-house which greatly improved working conditions.

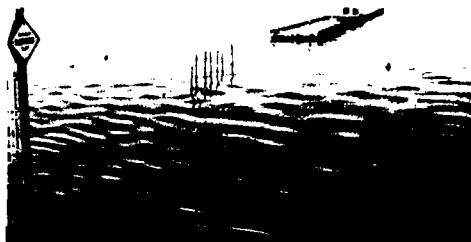
Photo F-22. Photo showing the wave array anchored in the vacant pipe-tire breakwater location.

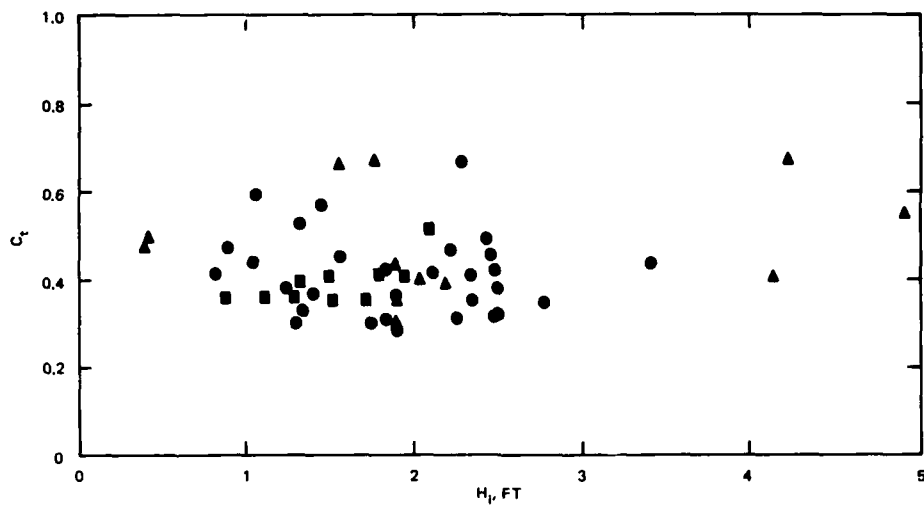
FIGURE G-6. Transmission Coefficient, C_t , versus Incident Wave Height, H_i , Concrete Breakwater

Figures G-6 and G-7 show wave transmission characteristics of the three floating breakwater configurations. In figure G-6 the wave transmission coefficient, C_t , is plotted versus the incident wave height, H_i . The transmission coefficient is centered on 0.4. Previous model test data show that, normally, wave transmission characteristics are very dependent on the wave period. However, as described in paragraph 5 of the main report, the geographical features of the West Point test site limited the range of wave periods for which meaningful data could be collected. This conclusion is confirmed by figure G-7 which is a plot of transmission coefficient versus wave period. The transmission coefficient converges on 0.4, and the range of wave periods is limited. Because of this limited range of wave period, no definite conclusions can be made about wave period effect. Figures G-6 and G-7 indicate also that the various configurations of the concrete floats had no significant effect on the wave transmission coefficient.

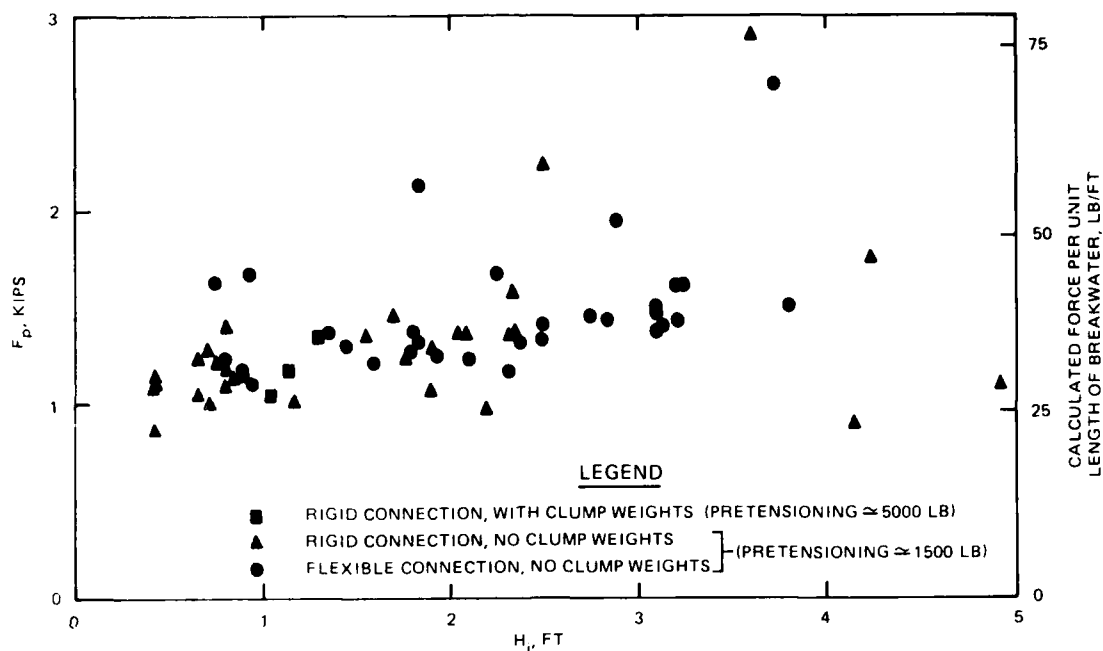
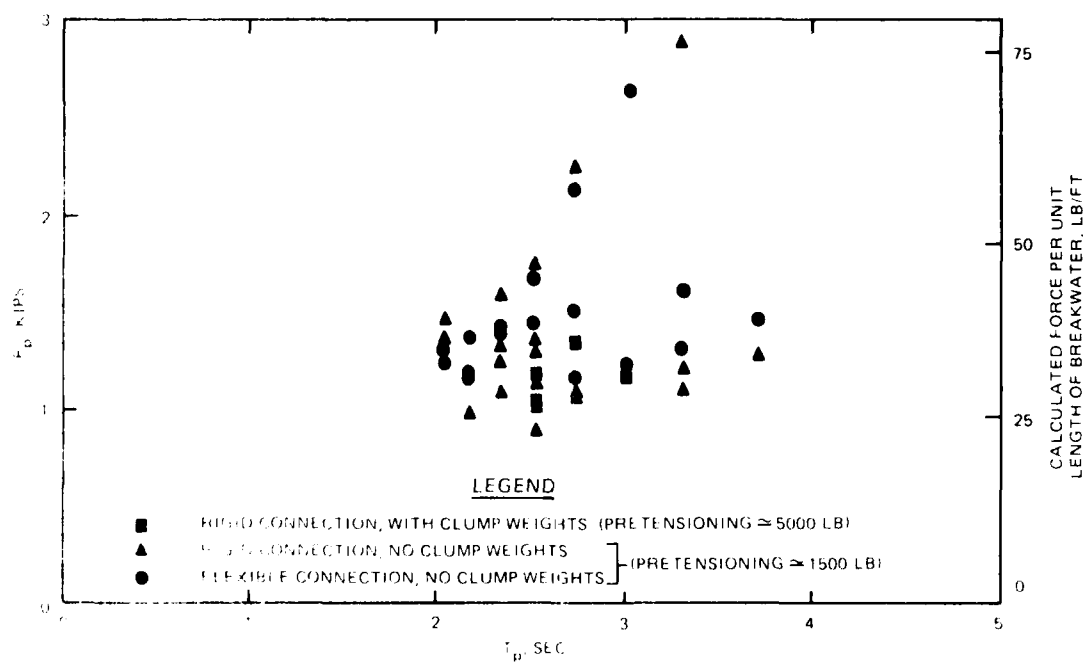
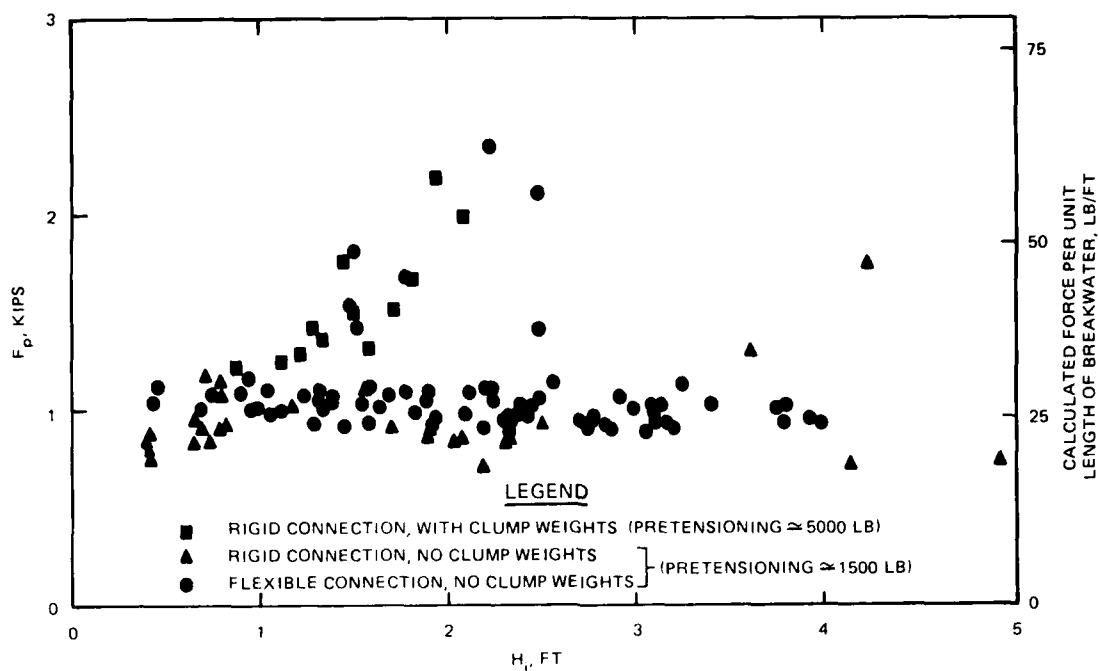
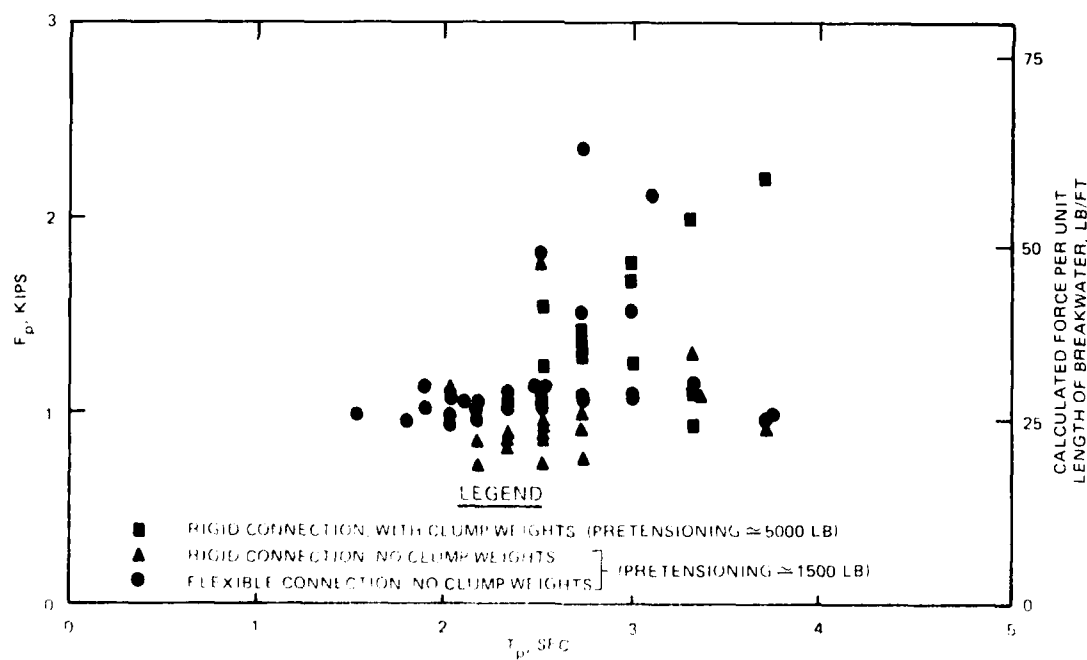
The anchor force data for channels 4 and 7, upper and lower load cells on the southwest mooring line, are shown in figures G-8, G-9, G-10, and G-11. Figures G-8 and G-10 are plots of the mooring line force, F_p , measured in one mooring line versus incident wave height, H_i ; whereas, figures G-9 and G-11 present the mooring line force versus the wave period of peak energy density,

T_p . There does not appear to be a strong dependence of anchor forces versus wave height or wave period. The data plots indicate in general that

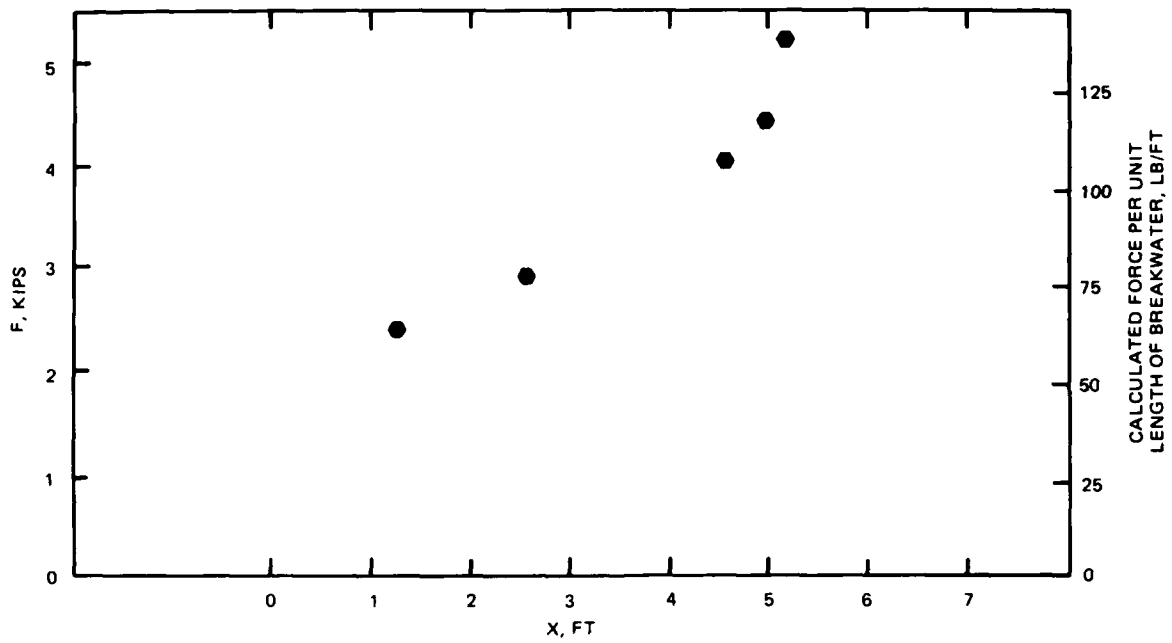
FIGURE G-12. Anchor Line Force, F , versus Horizontal Displacement, X , Concrete Breakwater (Channel 4)

3.02 Pull Test. A 110-ft tug was used to conduct a pull test on the concrete breakwater. The purpose of the pull test was to determine the anchor stiffness (spring constant) of the mooring lines, which is an important physical characteristic in the design of mooring systems. While the tug pulled on the breakwater, the x-, y-, and z-position of the breakwater, the force on the tow line, and the forces in the mooring lines were measured. The results of this test are plotted in figure G-12. The anchor stiffness, in kips per foot, gradually increases to a load of approximately 4 kips for a horizontal displacement of 4.5 ft from the neutral position. The anchor stiffness then increases dramatically to 5.2 kips at a displacement of 5.2 ft.

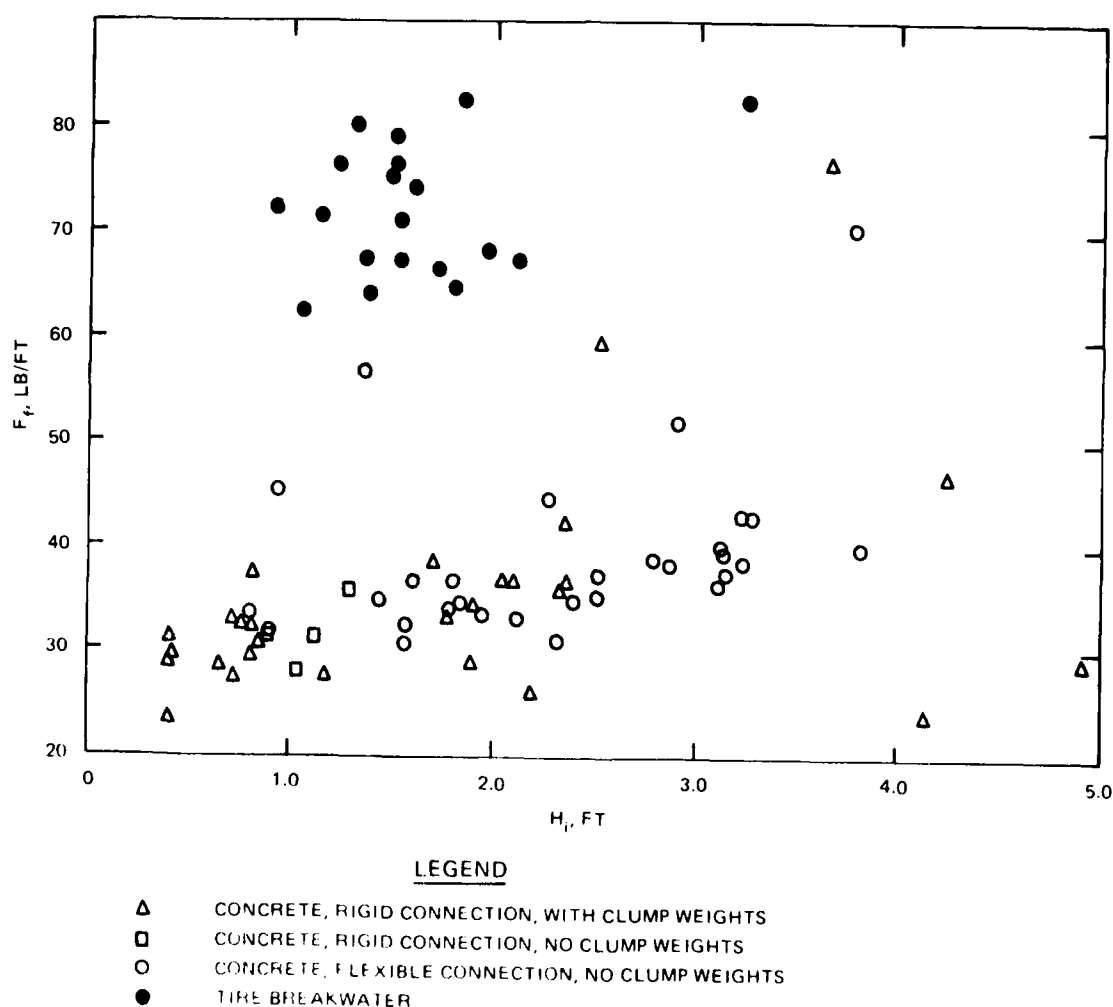
FIGURE G-19. Anchor Line Force per Foot of Breakwater, F_t , versus Incident Wave Height, H_i

Figure G-19 shows a comparison of the anchor forces for the two breakwaters. In order to compare these two, the anchor force data are presented per linear foot of breakwater. These values were calculated by assuming that the force in an anchor line was distributed over a given length of breakwater depending on the location of the anchor line/breakwater connection and the distance to adjacent anchor lines. For the concrete breakwater, it was assumed that the force on the center mooring line was distributed over a length of 37.5 ft and that for the tire breakwater the force on the center mooring line was distributed over a length of 12.5 ft. Due to extensive design differences between the two breakwaters and their anchor systems, a direct comparison is difficult. Figure G-19 implies that the pipe-tire breakwater experienced

significantly greater anchor loads per foot of breakwater. However, it should be noted that forces measured in individual lines on the concrete breakwater were actually greater than those measured in individual pipe-tire breakwater anchor lines. This is shown in figures G-9, G-11, and G-16. Nevertheless, because of wider spacing of the concrete breakwater lines (3 lines per 75 ft as opposed to 9 lines per 100 ft for the tire breakwater), the force in a concrete breakwater line was distributed over a greater length of breakwater.

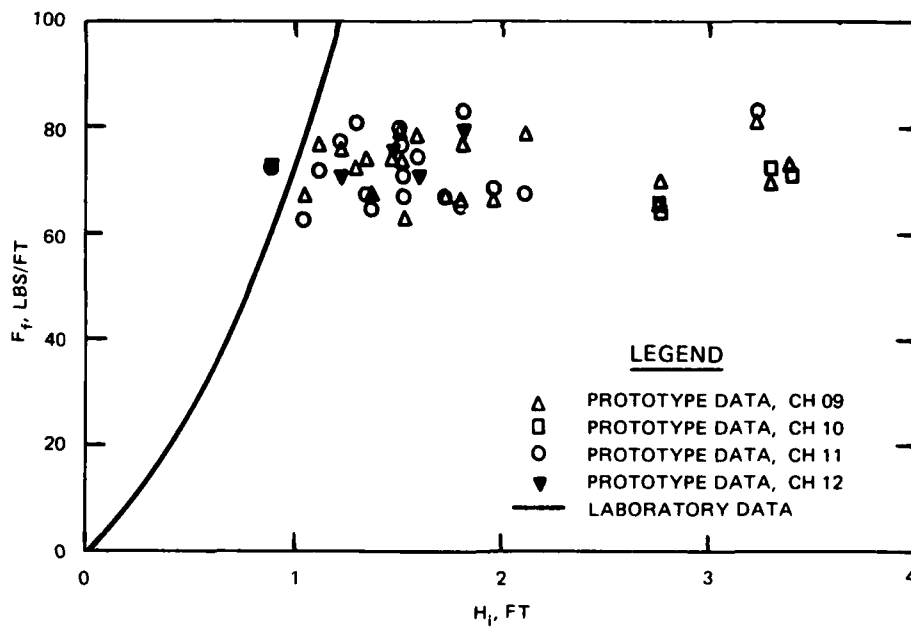
FIGURE G-22. Anchor Line Force per Foot of Breakwater, F_t , versus Incident Wave Height, H_i , Pipe-Tire Breakwater

Figure G-22 compares the anchor force measurements collected in the prototype for the tire breakwater to Harms' laboratory data. The prototype and model data differ significantly. The anchor forces in the prototype are nearly constant with an increasing wave height, while the model anchor forces increase with an increasing wave height. The difference between the prototype and model results probably is related to dissimilarities in the anchor system and test conditions. The actual tire mat geometry was the same; however, there were significant differences in the depth of water, anchoring system design, mooring line elasticities, and ratio of breakwater draft to water depth.
